## **QualityWorX CTS DataHub Case Study**

# Automotive OEM uses data analysis and visualization to eliminate bottleneck and improve FTT in hours

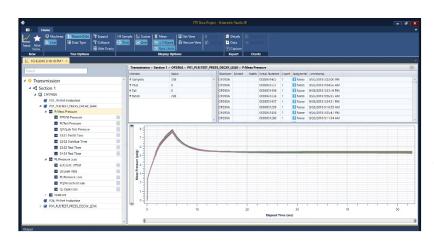
Figure 1: Overlaying the measured pressure values provides a comprehensive visualization of the stability of the pressure curve across the entire test cycle.

The QualityWorX CTS DataHub was connected to the CTS Sentinel I28 leak test instrument resident at one of the test stations to upload live production test data. After 100 parts moved through production and leak tests were conducted on each, data was ready for analysis in Sciemetric Studio, the advanced analytics software provided as part of the QualityWorX CTS DataHub solution. Analysis of the collected pressure waveforms pointed to a condition where a valve within the transmission assembly may not have been opening, causing a slower pressurization of the Torque Converter cavity. This added to cycle time while also compromising test reliability.

Armed with insight derived directly from the pressure waveforms, the team adjusted the fill pressure and fill time to sufficiently pressurize the entire transmission to a state of equilibrium. The higher pressure fill and added fill time helped to mitigate the impact of the air interacting with the transmission fluid which was creating additional variability in the leak test results. Two hundred more parts were run with the optimized program. The resulting digital process signatures clearly indicated that the combination of the higher pressure fill and extended fill time provided a much more stable and reliable process.

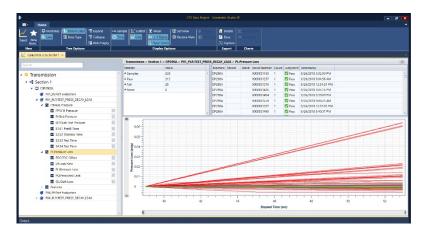
Figure 2: Simple visualization of pressure loss values highlights those measurements that are outside the normal population of results. In this case, the data shows substantial variation in the measured pressure loss values across a population of test results.

The waveform data allowed the manufacturer to fully visualize the entire pressure curve, providing unique insight into the leak test in a very short period of time. Before the process changes were implemented, the cycle time was 67 seconds. After implementing the changes, cycle time was reduced by 14 seconds, and FTT
